ASD-TDR-64-3

● **Impact Failure of Pressure  
Vessels - Part 2**

**ASD Technical Documentary Report No. ASD-TDR-64-3  
JANUARY 1964 • AFSC Projects 9850, 2835**

(Prepared under Contract AF08(635)-2889 by Aero-Space Division,  
The Boeing Company, Seattle, Washington. Authors: G. T. Burch, Jr.,  
D. H. Lee, J. F. Lundberg)

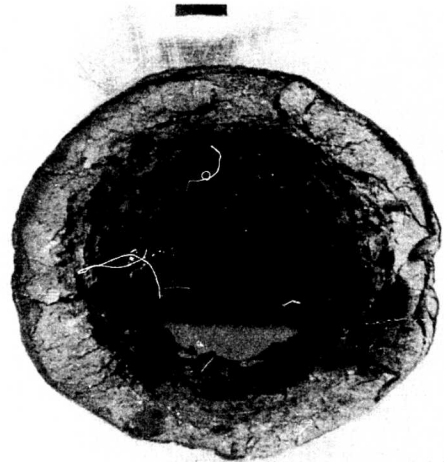
(b) Exit Side

Static Stress 40,000 psi

**Figure 6 FRACTURE MECHANICS TESTS —  
0.400-INCH 7075-T6 SPECIMENS  
1/4-Inch Lexan Cylinder Projectiles**

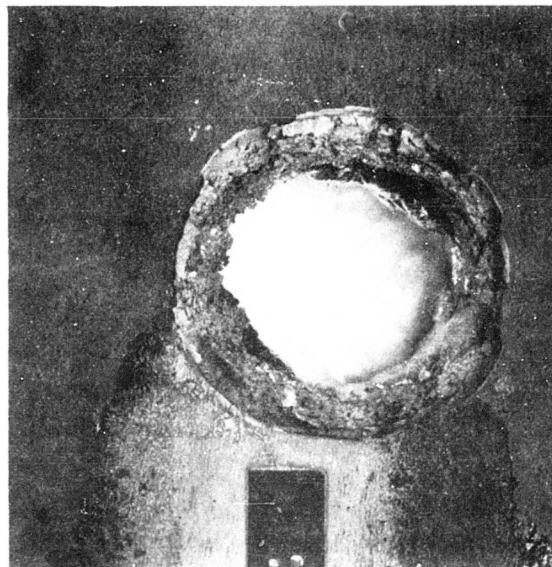
**Figure 9 FRACTURE MECHANICS TESTS -  
0.250-INCH LADISH D6AC SPECIMENS**

(a) Entrance Side

(b) Exit Side

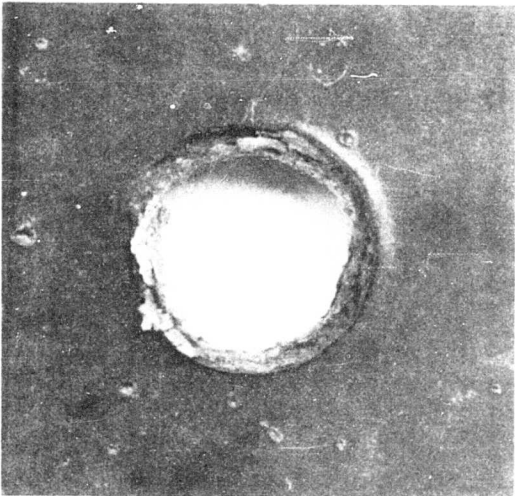
**Figure 11 EFFECT OF STATIC STRESS ON UNSHIELDED SPECIMENS**

(a) Static Stress 0 psi

(b) Static Stress 23,900 psi  
(40% Yield)

(c) Static Stress 36,800 psi  
(60% Yield)

(d) Static Stress 47,000 psi  
(80% Yield)

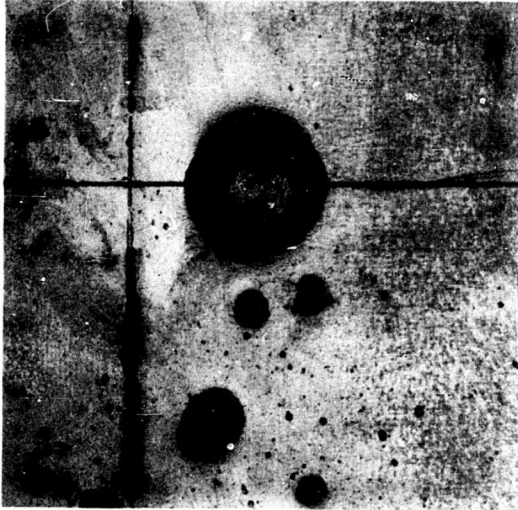
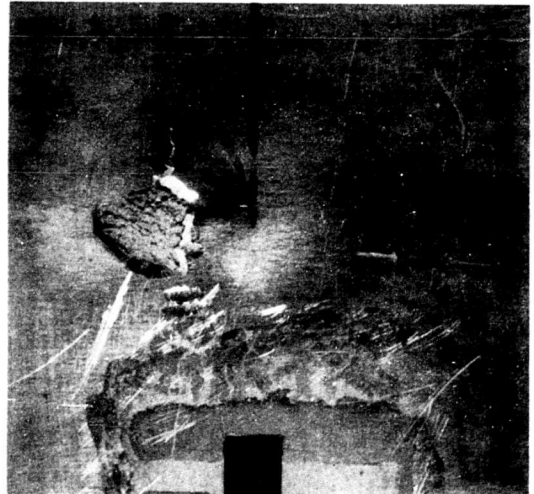
## Figure 14 PROJECTILE AND TARGET SCALING - CRATERS

0.375-Inch 2014-T6 Specimen  
Static Stress 35,700 psi 1/8-Inch Projectile

0.750-Inch 2014-T6 Specimen  
Static Stress 17,800 psi 1/4-Inch Projectile

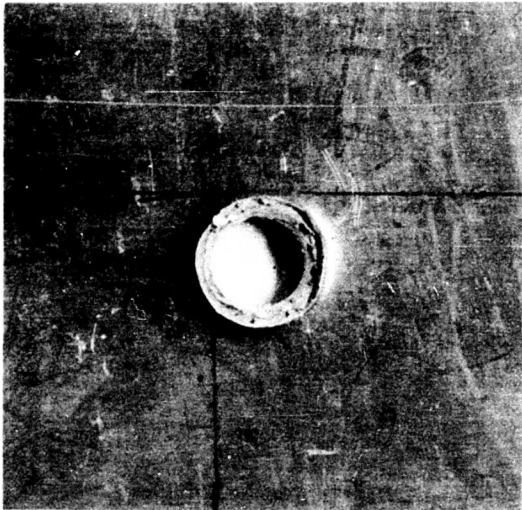
**Figure 15 PROJECTILE AND TARGET SCALING - PENETRATIONS**

0.160-Inch 2014-T6 Specimen  
1/8-Inch Projectile  
Sheet-thickness/Projectile-Diameter Ratio = 1.28  
SCALE:

0.375-Inch 2014-T6 Specimen  
1/4-Inch Projectile  
Sheet-Thickness/Projectile-Diameter Ratio = 1.50

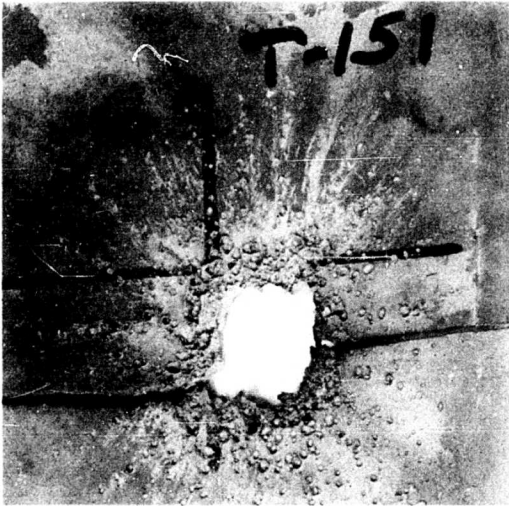
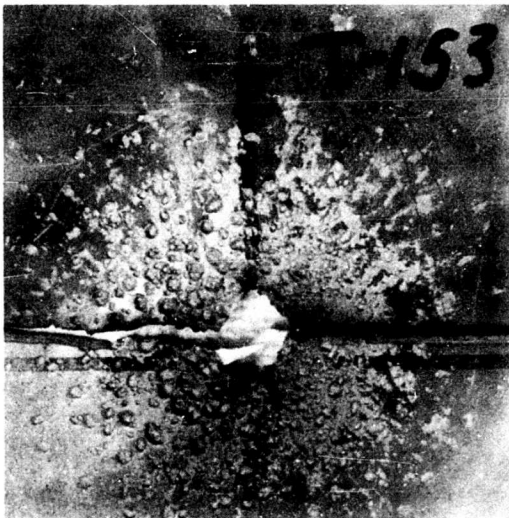
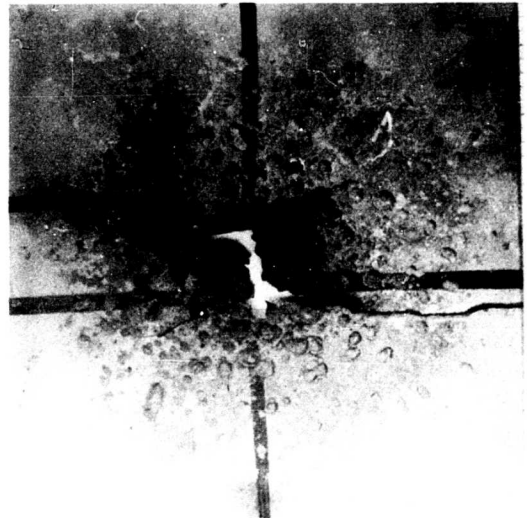
**Figure 16 EFFECT OF SHIELD THICKNESS - 1/4-INCH PROJECTILE**

(a) 0.040-Inch Shield

(b) 0.090-Inch Shield

(c) 0.160-Inch Shield

(d) 0.250-Inch Shield

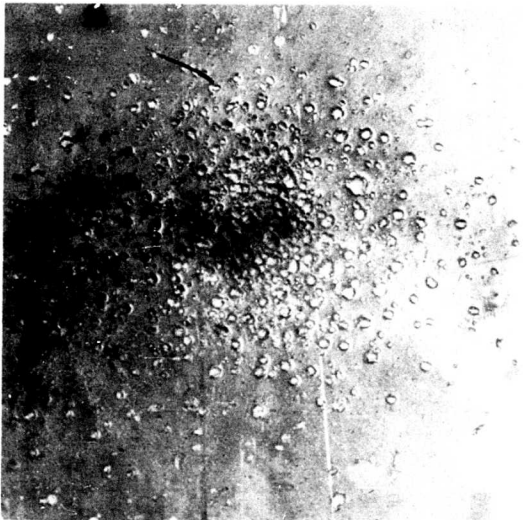
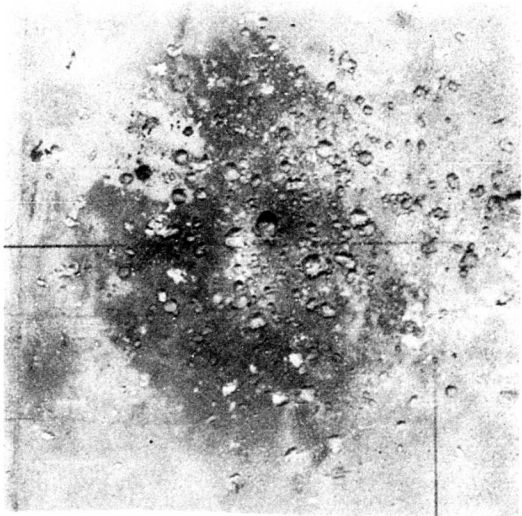
## Figure 17 EFFECT OF SHIELD THICKNESS - 1/8-INCH PROJECTILE

(a) 0.020-Inch Shield

(b) 0.040-Inch Shield

(c) 0.090-Inch Shield

(d) 0.160-Inch Shield

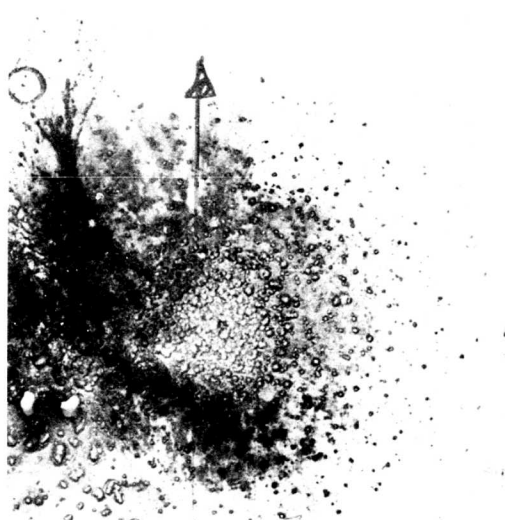
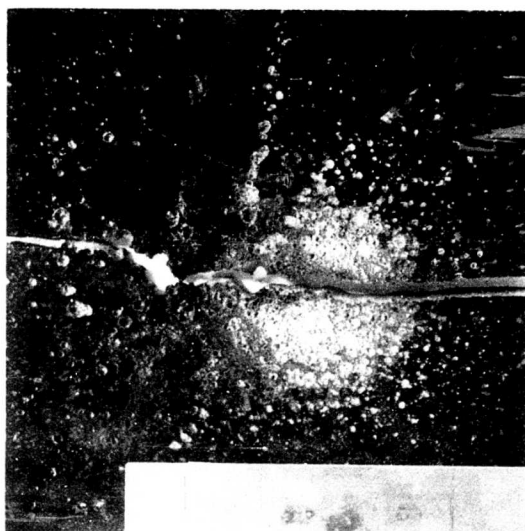
**Figure 21 DAMAGE DUE TO IMPACT  
OF 1/8-INCH PROJECTILE PLUS SABOT**

(a) Test R-80 - No Penetration

(b) Test R-180 - Penetrated and Cracked  
(Crack extends through  
three largest holes)

(c) Test T-95 - Fractured Due to Impact
